## Case Study

### Site Description - Trichloroethane (TCE) and Perchloroethylene (PCE) contaminated groundwater.

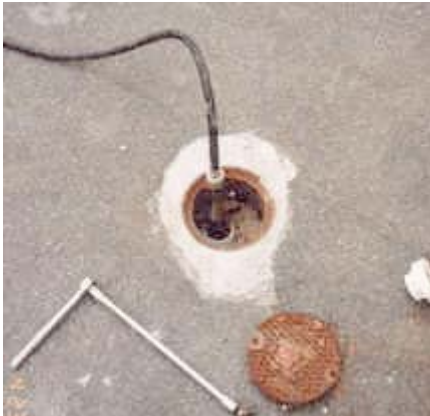
**Photo of an inoculation point**

**Recommended Treatment Method (in-situ):** Thirty-two (32) inoculation points were driven to the bedrock surface and set with 1/2 inch PVC well screen. The points were arranged in a grid pattern from upgradients of the known extent of contamination to the property boundaries. The microbial products were mixed with nutrients, biocatalyst, and injected into the points and the impacted monitoring wells.
