## Case Study

### Site Description – Diesel fuel spill under railyard tracks

**Site Location:** Fort Wayne, Indiana

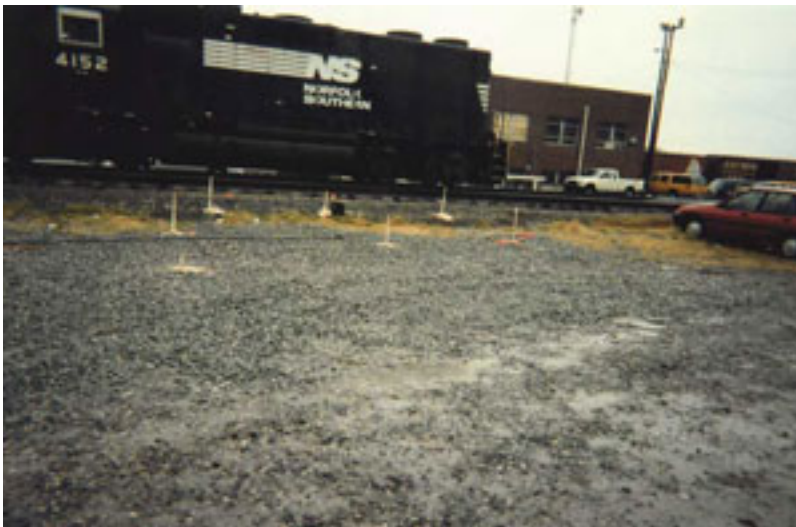
**Photo 1** 10 injections points allowed us to introduce the product with minimal disruptions to trains and road traffic.

To treat the area we developed a matrix that contained 10 injection points. Each of the sites had vertical holes drilled and PVC pipes were put into the hole. The 10 injection points allowed us to use pressure injection and gravity feeds to add microbes to the area.

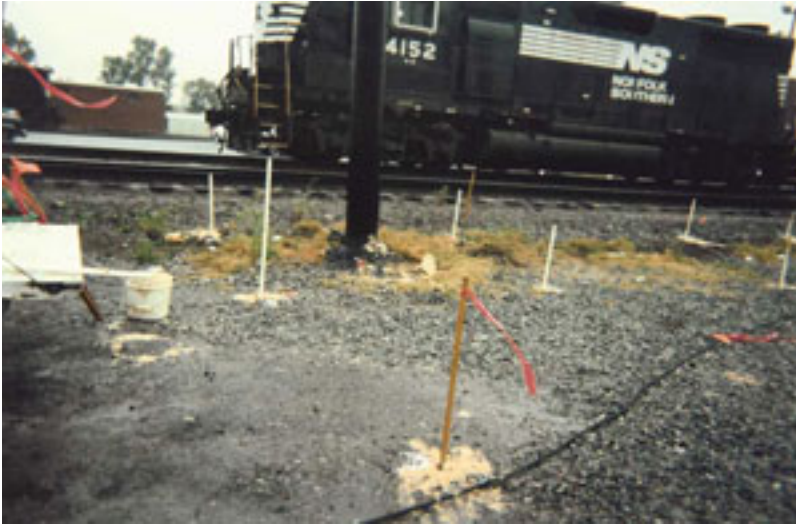
**Photograph 2** Injection points within 4 feet of train tracks as trains pass by.

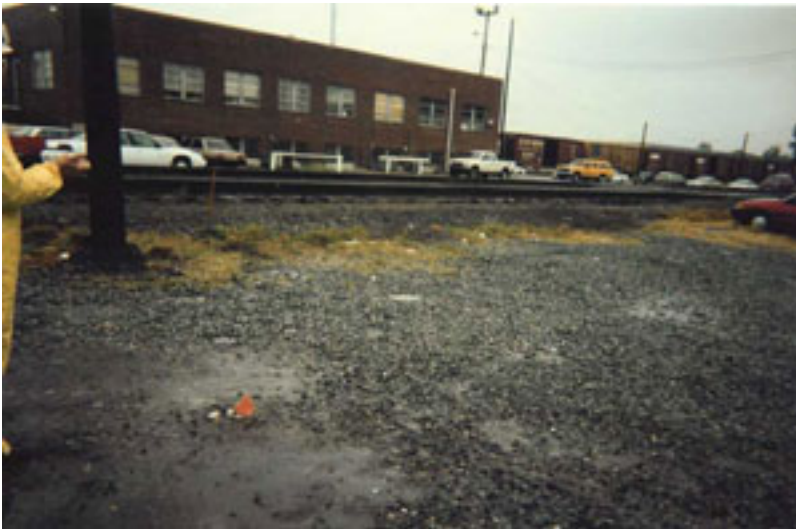
**Photograph 3** After treatment the injection points were left in place but cut off at ground level.

The weather conditions during treatments were mostly raining with temperatures consistently in the mid 50's. After treatment the injection points were cutoff at ground level. This allowed us to monitor the groundwater as well as allow us to re-treat potential hot spots if they arose.
